# Living Shorelines Tour

## Site #1 - Planter Breakwaters

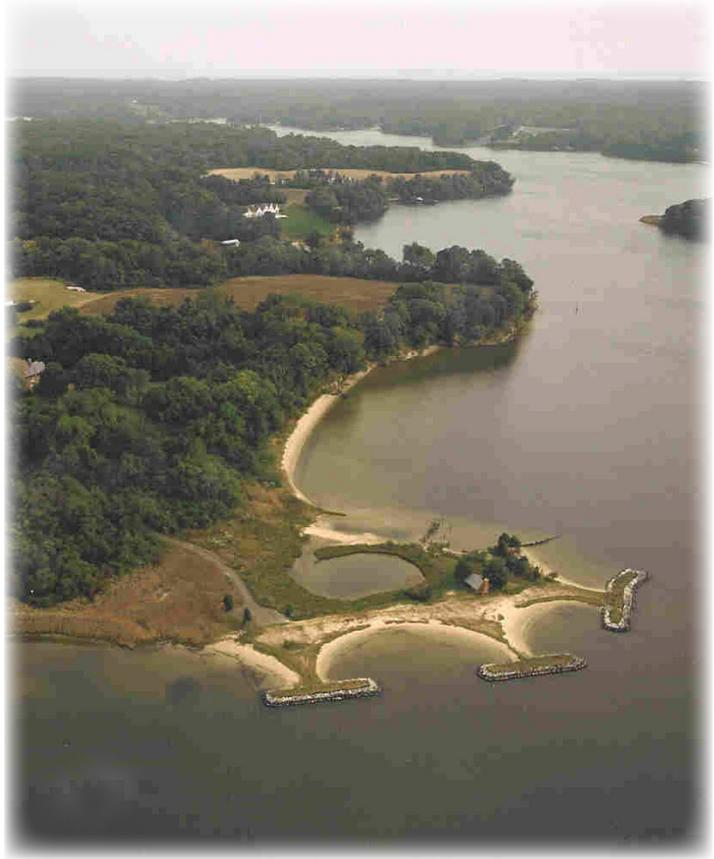
*Aerial view of planter breakwaters at Peterson Point.*

The “planter” breakwaters at JPPM provide “headland” (a higher point of land extending into the water) erosion control through the breakwater structure, beach fill material and vegetation. Key design considerations are breakwater length; distance offshore; gap width between breakwaters; and the maximum embayment indentation between breakwaters.

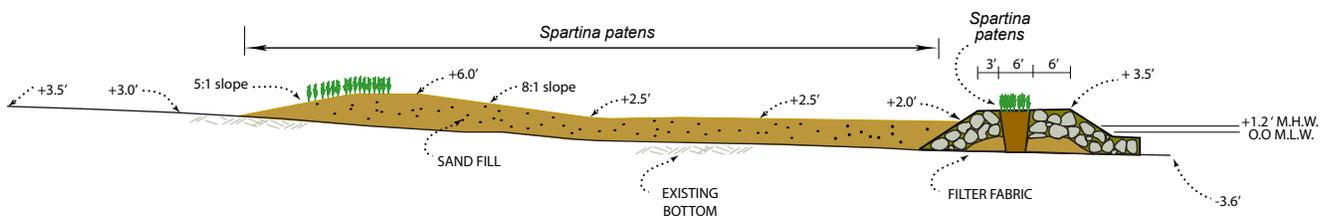
*Typical Planter Breakwater/Beach Section*

Headland breakwater design is complex, involving a thorough understanding of the local wave climate and shoreline geomorphology. To improve the breakwater's aesthetic appearance, saltmeadow hay (*Spartina patens*) and salt tolerant shrubs commonly found on high marshes in the Chesapeake, were placed in the center of each breakwater. The breakwater stands at 3.5' above mean low water and features sloping fronts with heavy armor stone. Sand fill material was brought in during construction to build the breakwater and create a beach.

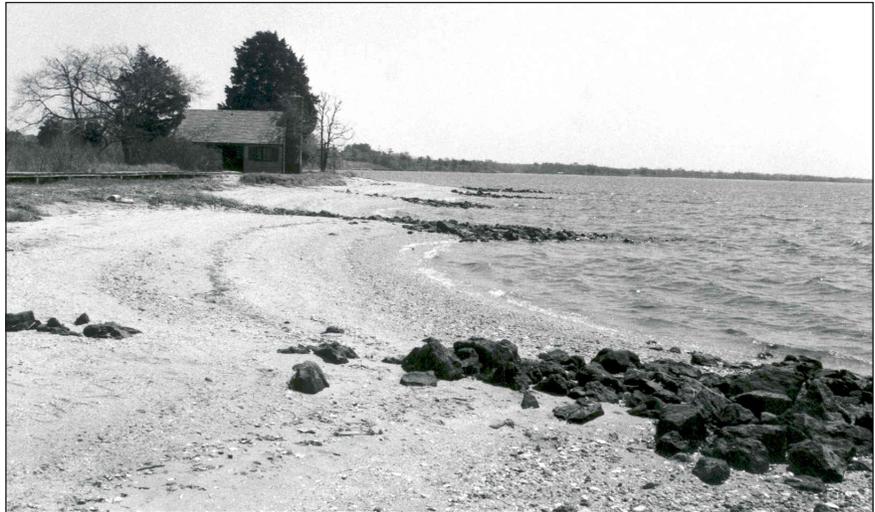
*Pre-construction photo showing former stone groins and low elevation beach.*

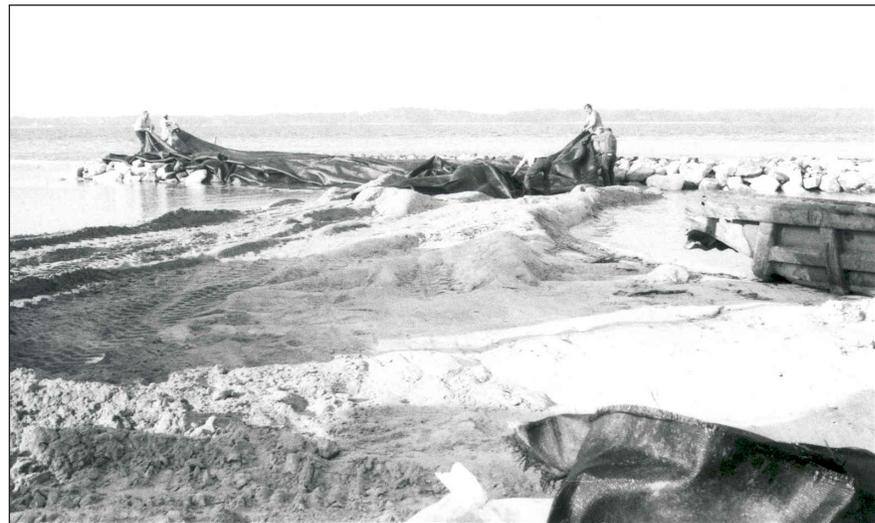
*Photo during construction showing filter cloth lining placed in planting bed and sand fill before grading.*

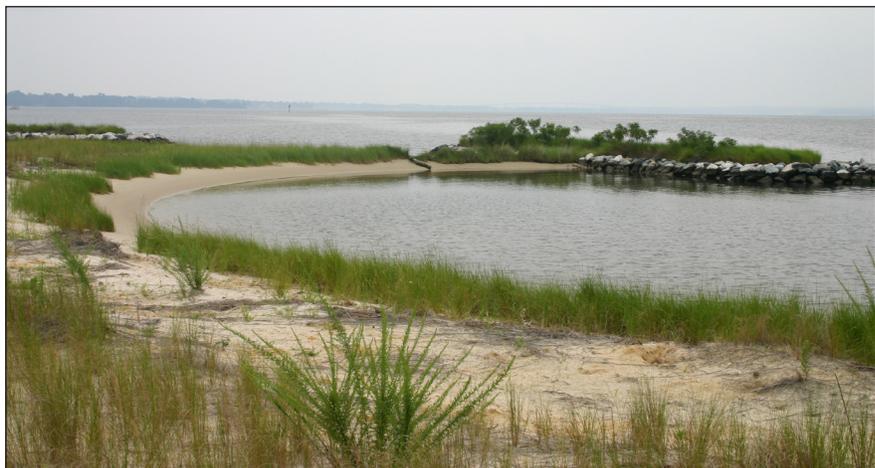
*Post-construction photo taken in the summer of 2004.*

Subsequently, the sand between breakwaters was placed in a stable pocket beach configuration. Saltmeadow hay was planted on the beach above the mean tide line. Today, in the "low" marsh zone, flooded by daily tides, smooth cordgrass (*Spartina alterniflora*) can be seen. In the "high" marsh, above mean high tide, saltmeadow hay is well established. At the rear of the beach, flooded only during storm events, a narrow band of "dune grass" (*Ammophila breviligulata*) exists in some spots.
